B737 AC motor pump upgrade

Issue/application

Solution

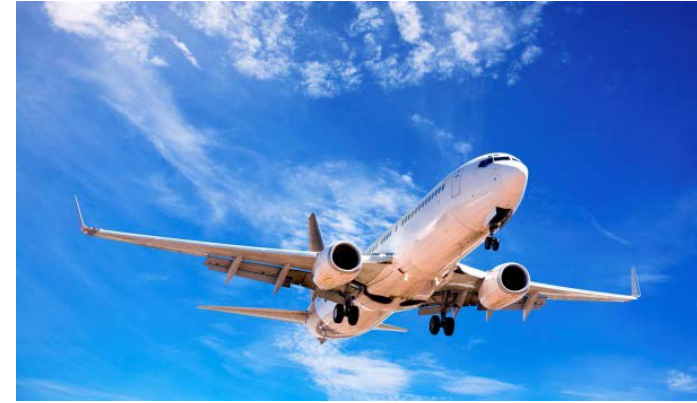
- B737 classic through max
- AC motor-pump overheat failure possible
- Current motor design does not adequately contain 2 phase electrical failure
- Model MPEV3-056-7A / PN 887477
 - Boeing PN 10-60556-32
- Pump overheat / stator failure

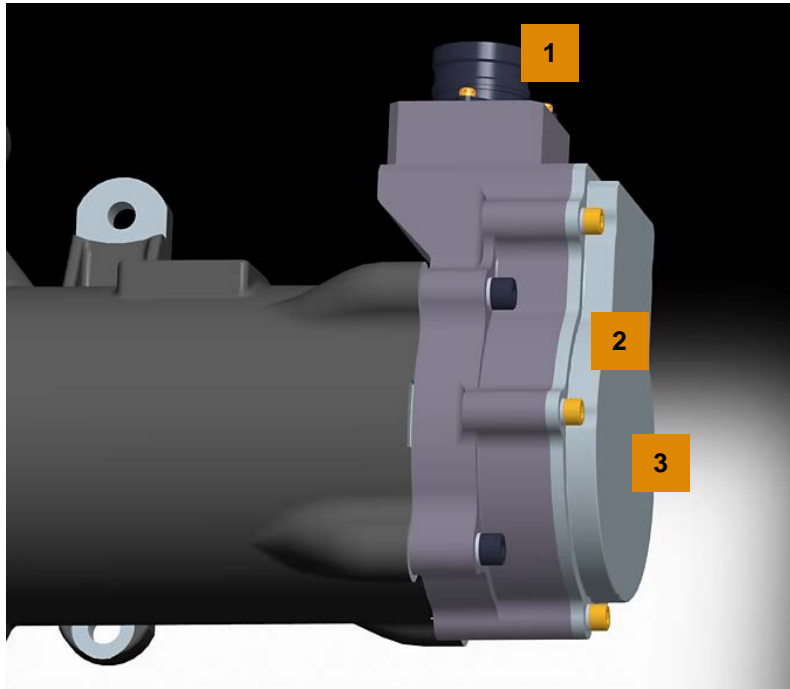
Envelope exterior

- 1 Aircraft connections identical
- 2 New machined cover and end bell
- 3 New envelope validated by Boeing

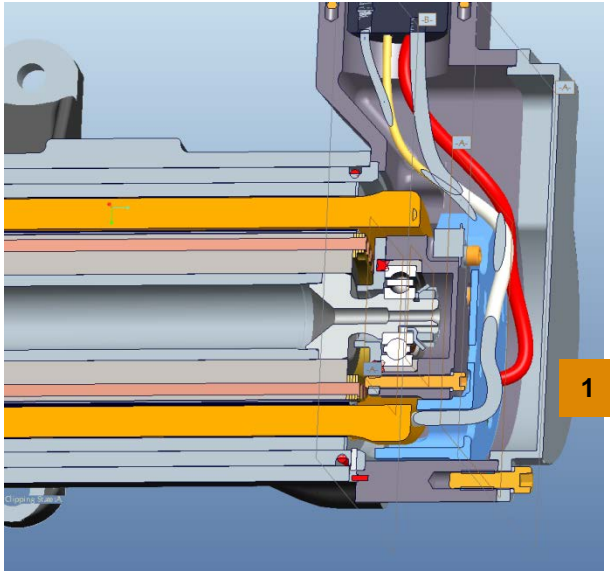
Upgraded configuration

The Boeing test hardware indicates that the stator end-windings expose the ACMP interior to high temperature and energized conductive particles.

Ensure thermal and electrical isolation by incorporating two high-temperature non-conductive shields between the structure and the stator windings.

1 New insulator providing end turn shielding

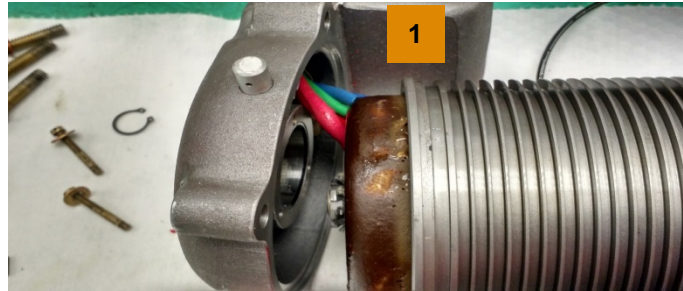
Incumbent configuration

1 No shielding in the incumbent configuration

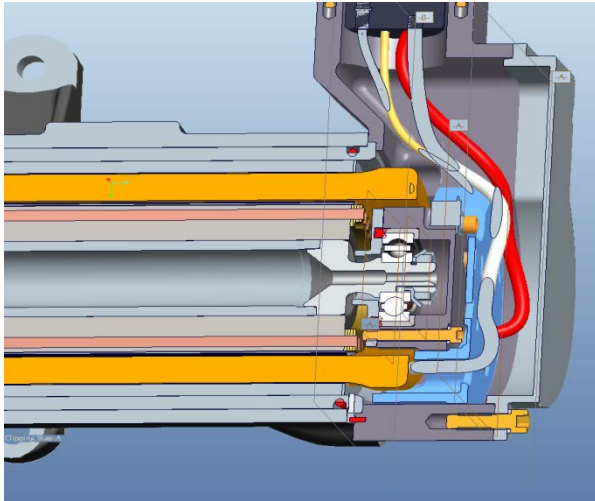
Validation of the design with separation of lead wires has demonstrated inconsistency (pass/fail) during 2 phase testing. Time to failure is too large and the external temperature exceeds the limit of 392°F

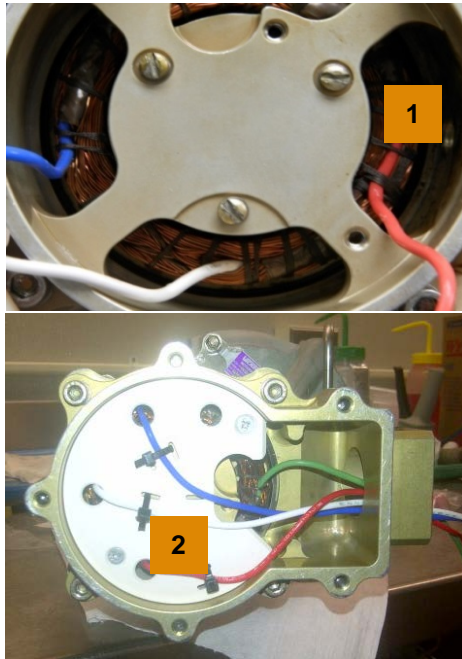
Upgraded configuration

Test hardware indicates that the stator phase leads should be isolated from each other and the structure to prevent internal damage.

Test hardware indicates that the leads should be supported to prevent post-damage contact with conductive surfaces.

Ensure electrical isolation by redesigning the stator, incorporating non-conductive shields, and implementing improved wire routing.

Ensure isolation after the phase lead is severed from the stator end-windings by incorporating wiring supports into the non-conductive shield.

- 1 90 deg. phase lead separation
- 2 New Insulator providing phase lead isolation and support

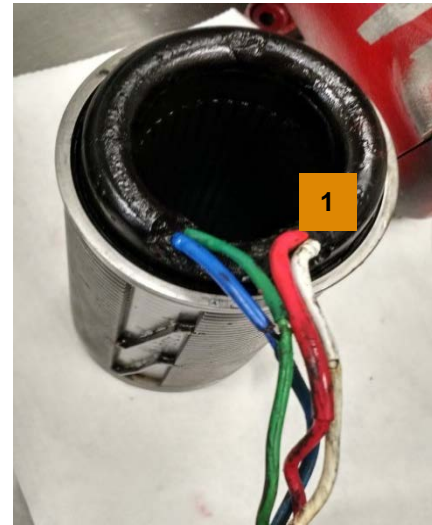
Incumbent configuration

- 1 No phase lead spacing, isolation, or support
