# B787 Fuel Pump Technical Update - F202

**Stuart Tucker** Product Support & Technical Services Manager  
**Billy Walker** Technical Support Team Leader  
Aftermarket FMC

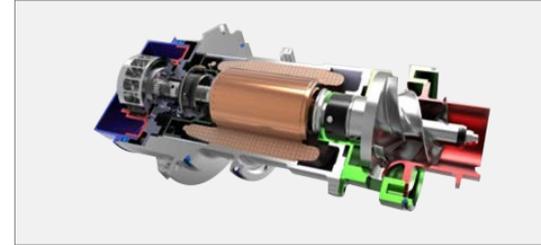
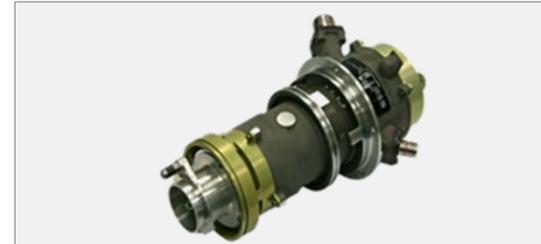
### Failure of Stator Windings on in-service aircraft

- Initial determination – damage to Stator Winding insulation during assembly resulting in weakened electrical resistance causing electrical short circuit
- Manufacturing process change implemented to address possible insulation damage during assembly
- Part number roll from -1300 to -1400 identifying process change
- Fleet retrofit of all 1300 pumps – Complete

**Issue diminished but was not resolved**

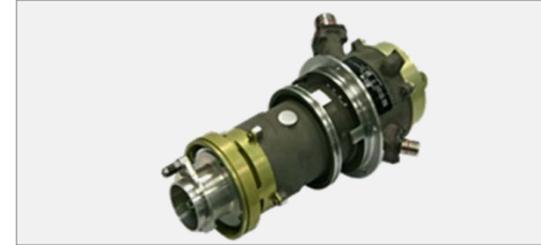
No discernable pattern has been identified for field failures; hours, cycles, engine type, location, flight profile

- Eaton has concluded it's power interrupt testing and was unable to replicate the failure seen on in service aircraft
- Additional improvements in stator winding to enhance insulation
  - Trickle impregnation of insulating varnish
  - Grade 3 wire (thicker insulation)
  - Coil separators (increases insulation between coils)
