B787 Program update - F205

Stuart Tucker Product Support & Technical Services Manager
Billy Walker Technical Support Team Leader
Aftermarket FMC

Boeing 787 Fuel system background

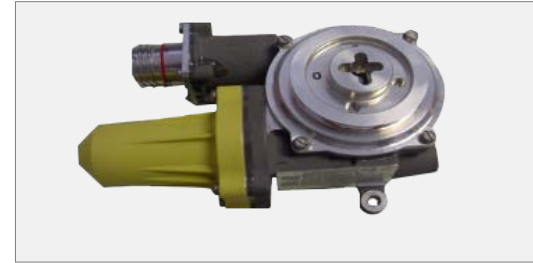
787 In-service issues – actuator upgrade

FAA mandated change - additional actuator position annunciation required

- Part number roll to 53-0049 incorporated at line 126
- In support of AD No. 2014-NM-068-AD
- 2 Phase implementation
 - Phase one eliminates need to inspect 3 actuator positions every 10 days
 - Phase two required for full compliance
- Existing on wing units being updated
- Seed units provided to operators

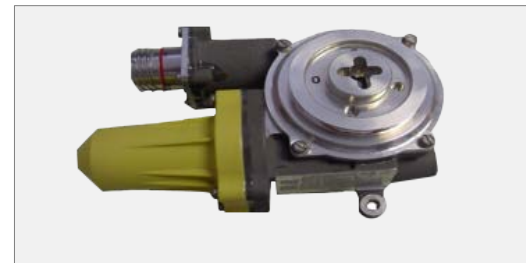
787 In-service issues – actuator C2 capacitor failure

P/N 53-0037/49 capacitor C2 located on motor circuit board

- Some incidents of C2 capacitor located in motor module cracking resulting in actuator failure
- SB 53-0037-28-02 issued to change motor module to one containing new capacitor (applies to line 126 and earlier)
- Positions - Main tank refuel (4), engine fuel shutoff (2) and APU fuel shutoff (1)
- Part plan
- Timing

Joint planning with Boeing

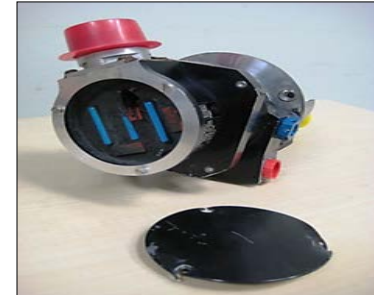
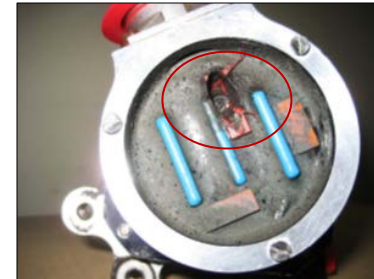
Some operators advised issues relating to the CE2825801 APU DC Pump circuit breaker tripping and the APU pump being inoperative

Pump end cap was also found detached

Investigations revealed damage to the MOV (Metal Oxide Varistor), and in some cases damaged capacitors

Further extensive testing is being planned to analyze and advise potential design changes to the electronics circuit

Additional pump cycling tests to be run by Eaton, to gather data relating to any voltage surges and/or any transient current spikes
