A380 Kevlar hose update

- A380 hoses experiencing “weeping”
- “Weeping” phenomenon attributed to microvoids in Kevlar hose inner tube
- “Weeping” occurs predominantly between 250 to 900 flight cycles
- Severity & occurrence varies by application
- Kevlar hoses replaced with steel braided hose in some instances
- “Weeping” hoses are removed and replaced causing disruption in airline operations

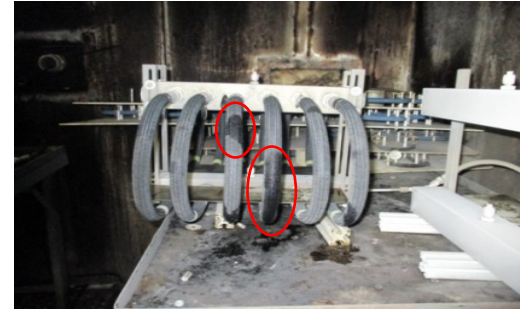
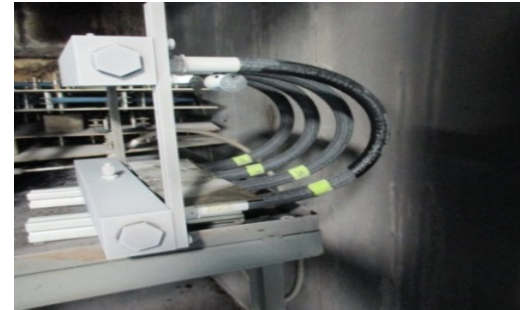
Examples of “weeping” phenomenon

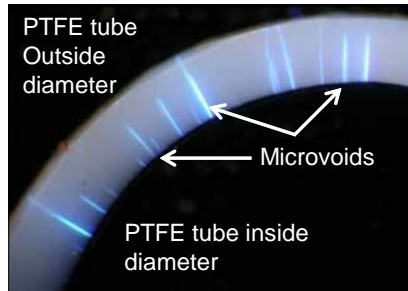
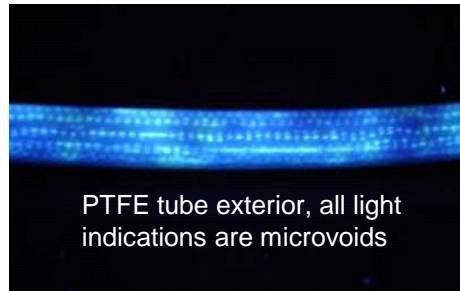
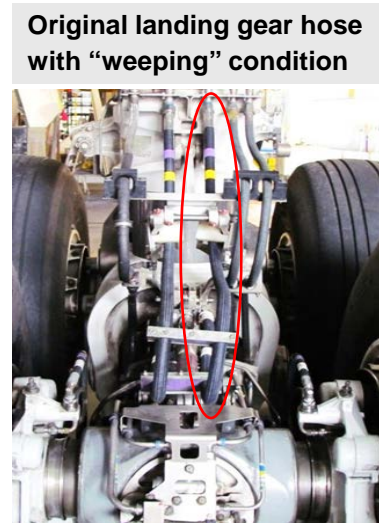
- First identified on A380 landing gear in 2009 (AE717558-046)
- Source identified as through-wall Microvoids which ran from inner diameter to outer diameter of inner PTFE tube
- Surfaced as an industry-wide problem
 - Internal benchmarking
 - SAE committee investigations

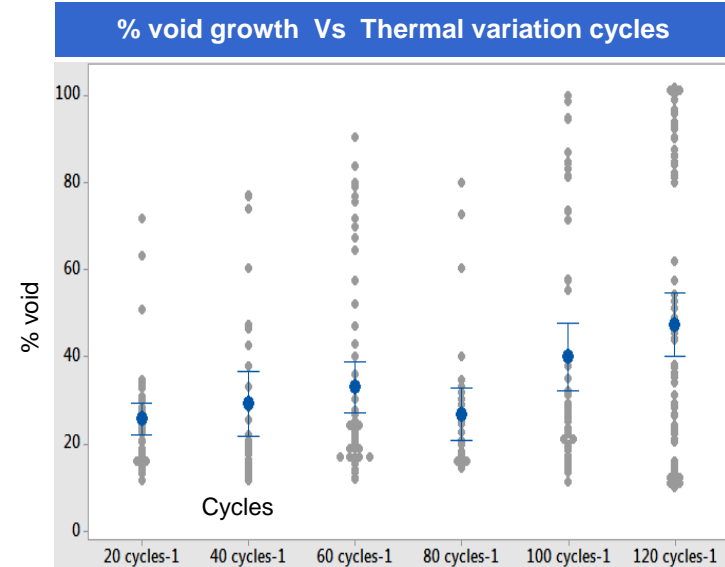
- As hose experiences thermal variation under pressure, microvoids grow until they are “through-wall”
- Weeping does not always occur when microvoids are through-wall but are indicators of potential weepage
- Severity depends on location, application and other factors

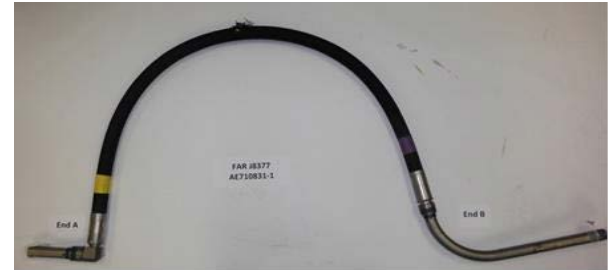
ABS1401SAAFFJ23 (Eaton P/N AE710788-1)

- 2 hoses identified as having weepage in A380 aircraft cargo bay (ABS1401SAAKJH19, ABS1401SAAFFJ23)
- Hose assemblies consist of Kevlar (size -16) hose with a jump-sized, swaged titanium Rynglok fitting on each end
- To date, 7 hose assemblies have been returned to Eaton for investigation
 - 5 different hose material lots
 - Assembled between July 2006 – November 2008

- Airbus and Eaton working jointly on CRES wire braid replacement for Kevlar for this application
- CRES wire braid hose is more rigid and will not induce movement in the hose assembly
- CRES wire braid hose will replace 2 part numbers (ABS1401SAAKJH19, ABS1401SAAFFJ23)
- Redesign of the clamp will be required to accommodate the new CRES hose

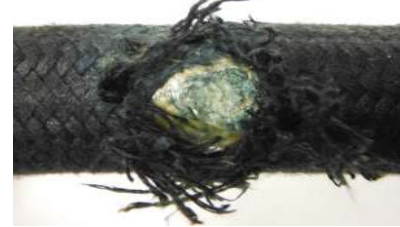
- Investigation into cargo bay hoses ongoing
- All hoses (except one) were removed for weepage. No failure occurred
- FAR J8378 failed due to a pre-sintered defect which occurred during pressure test after installation
- Returned hoses have exhibited varying levels of abrasion where the hose is clamped

Abrasion location at clamp interface

Returned Sample with Abrasion

- The hose is seeing movement during pressurization which is being constrained by the center clamp point
- As the hose moves, the surface of the hose rubs against the clamp resulting in abrasion of the outer cover
