A330/A340 Fuel pump airworthiness directive

SB 8810-28-03 Mk 001 / 002

SB 8810-28-05 MK100 / MK101

Airworthiness directive (EASA)

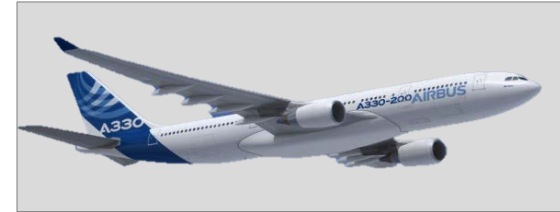
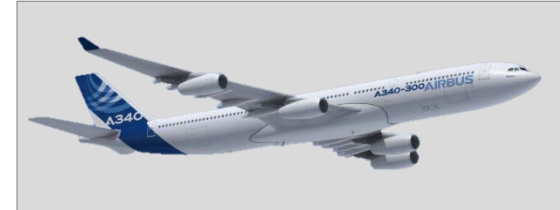
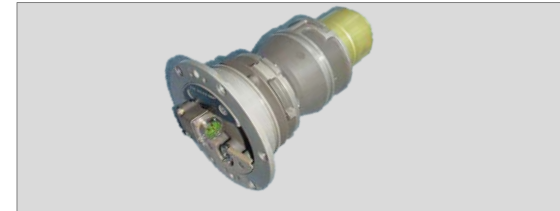
- **Platform:**
 - Airbus A330 / 340 family
- **Aircraft problem/impact:**
 - Ingress of moisture/water
- **Description of problem:**
 - Non operation of fuel pump
- **Identify assembly/part number:**
 - 568-1-28300-001/002/100/101
- **Consequence (s)**
 - Non operation of pump
 - Potential for fuel leak when aircraft side connector removed

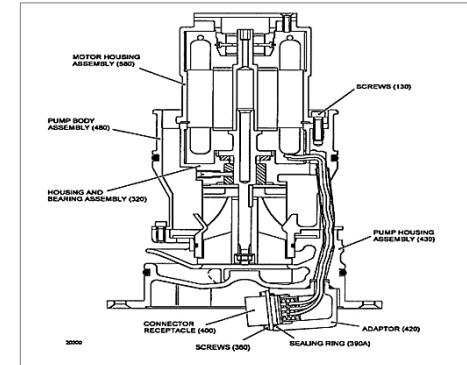
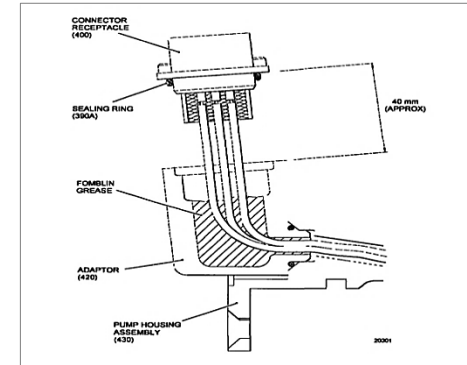
- Recommended SB released July 2nd 2001
- Moisture freezing behind connector causing mechanical damage
- Volume behind electrical connector reduced with the use of Fomblin grease

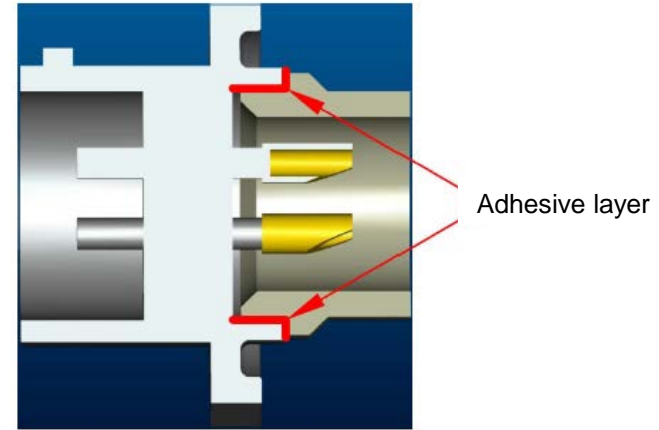
- Recommended SB released May 25th 2012
- Moisture degrading insulation resistance
- New connector introduced to prevent moisture
- Connector potted
