# A330/340 EDP Reliability & In Service Issues

**Steve Badenoch**

Product Support Manager  
Bedhampton FMC Hydraulics

# Rosan fitting – Problem Description

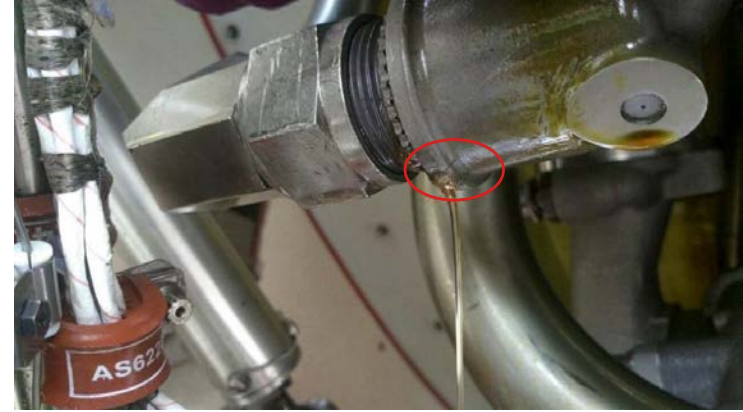
- Operator disruption due to leakage from outlet port fitting
- It is now the number 1 in service issue
- Recent analysis determined approximately 20% of returns to Bedhampton had a fitting issue
- Reported issues include external leakage and loose outlet fittings

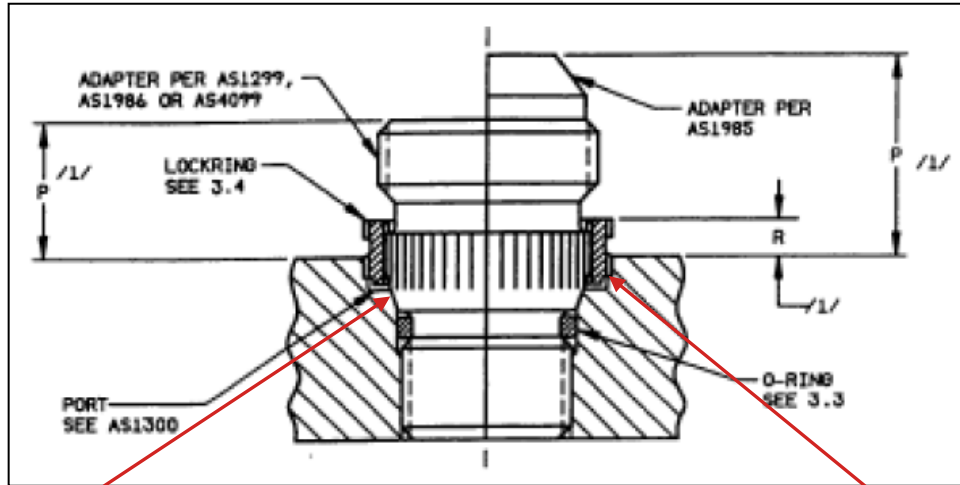
Metal to metal sealing chamfer

Locking ring & valve block serrations

Investigation has found these key features are known areas of wear resulting in external leakage.

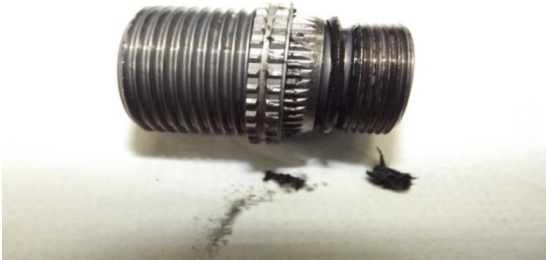
External fitting serration wear

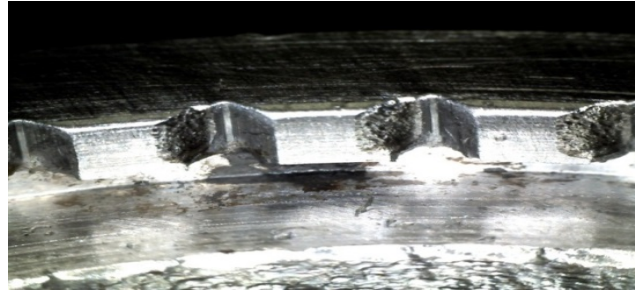
Valve block corresponding serration wear

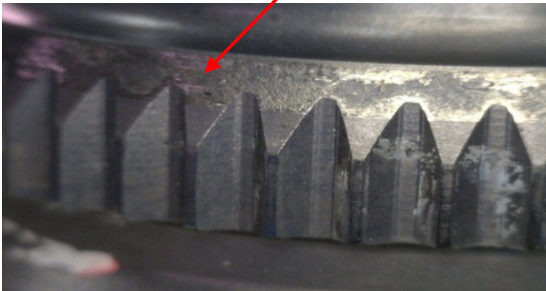
No chamfer wear or loss of material

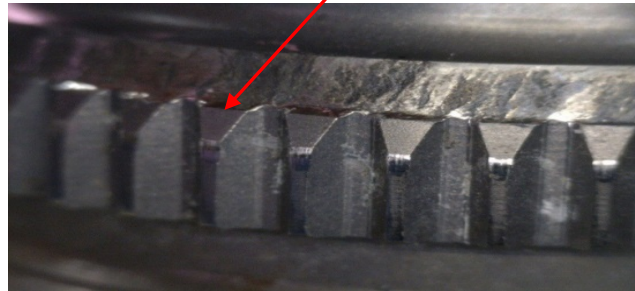
Chamfer wear resulting in material loss

- No EDP material defects or manufacturing issues.
- Removal of material on valve block and fitting results in loss of pre-load torque, fitting movement, seal fretting and leakage.
- Analysis confirms the vast majority of fitting leakage occurring on A330 Rolls Royce engines.
- Analysis also confirms most failures occurring on Green System.
- There is no relationship between flight hours and fitting leakage.

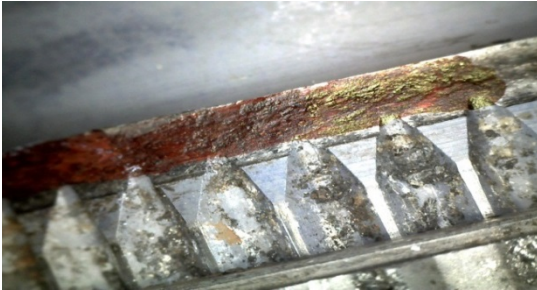
Fitting serration wear

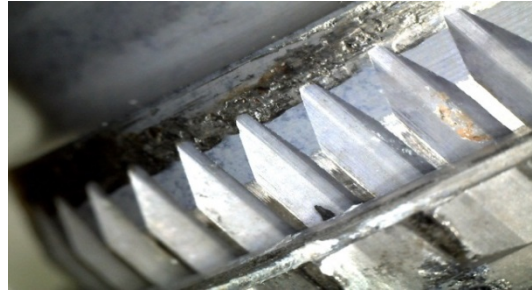
Fitting serration – No wear

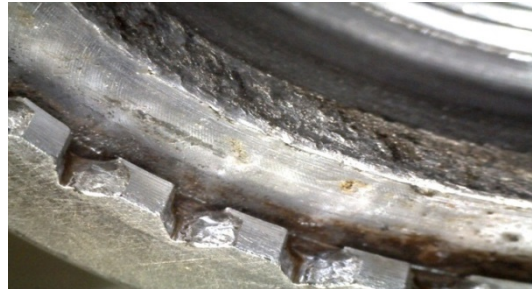
Valve block serration wear patterns

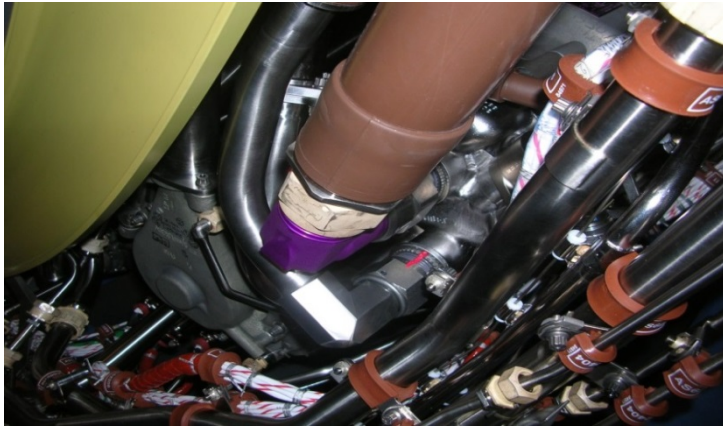
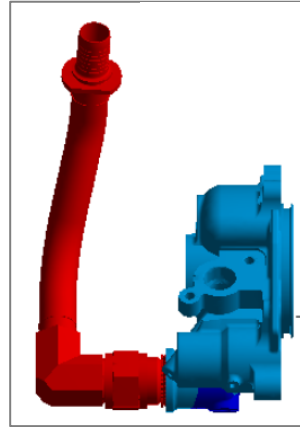
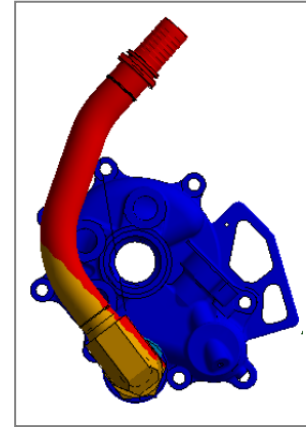
- Very tight installation
- Solid tube with right angled connection at port interface followed by a double kick
- Subsequent FEA has confirmed there is relative motion between the fitting and valve block causing wear to occur, this is caused by a number of factors.

Airbus has raised a Major In Service Problem (MISP) to resolve the Rosan fitting issue.

Airbus has formed and is leading a task force (Eaton, Airbus & Rolls-Royce) and all parties are working together to investigate and develop a viable solution.
