# A380 Engine Driven Pump Status Update

# Historical Background

# A380 EDP Manufacturing Issues / Retrofits

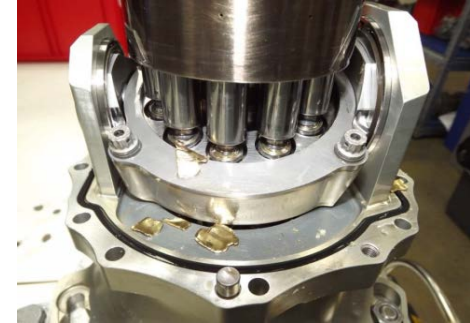
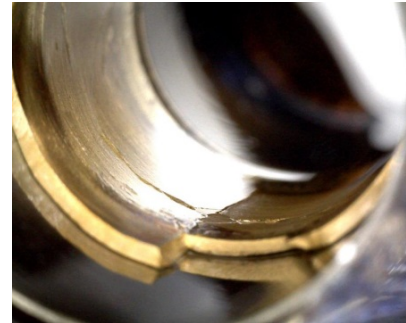
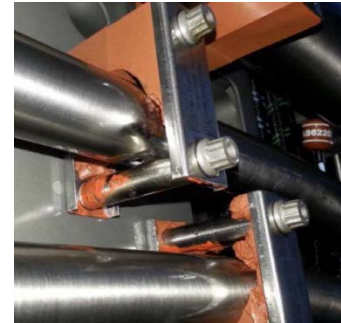
# A380 EDP Cylinder Block Sleeve Displacement

- In 2015 three A380 EDPs were removed for investigation due to reported high in service vibrations
- Following the events damage to hydraulic outlet pipe clamps and pipe leakage were noted on aircraft
- On investigation extracted cylinder block sleeves were discovered
- Further investigation revealed sleeve extraction was due to cracking
- This follows previous similar failures resulting in a fleet wide retrofit campaign

Investigation confirmed a new failure mode. The failure mechanism was not the same as previous sleeve displacement incidents.

Cracks were found on outer sleeve diameter and undetectable by NDT post swaging.

Root cause was linked to a swaging process change where the swaging operation method was changed from a vertical to horizontal method.

Horizontal swaging resulted in side loading the sleeve due to tool wear.

Side loading can cause the outer sleeve to fracture due to poor alignment.

- The key contributor is directly related to using the horizontal CNC milling machine to swage the sleeves causing mis-alignment
- This is eliminated by returning the swaging operation to a vertical press.
- Vertical swaging self aligns naturally to each bore and there is no opportunity for side loading to occur
- Worth mentioning is the fact that the vertical swaging operation used to retrofit the global fleet to the PV3-300-31N standard is a well proven and robust manufacturing process. There are no recorded incidents of sleeve displacements with 1000+ PV3-300-31N EDPs produced.
- All 203 affected units will be retrofitted with a new cylinder block– SIL 3032793-002-29-01 applies, retrofitted EDPs identified by S/N Suffix A. A total of 154 retrofits completed to date.

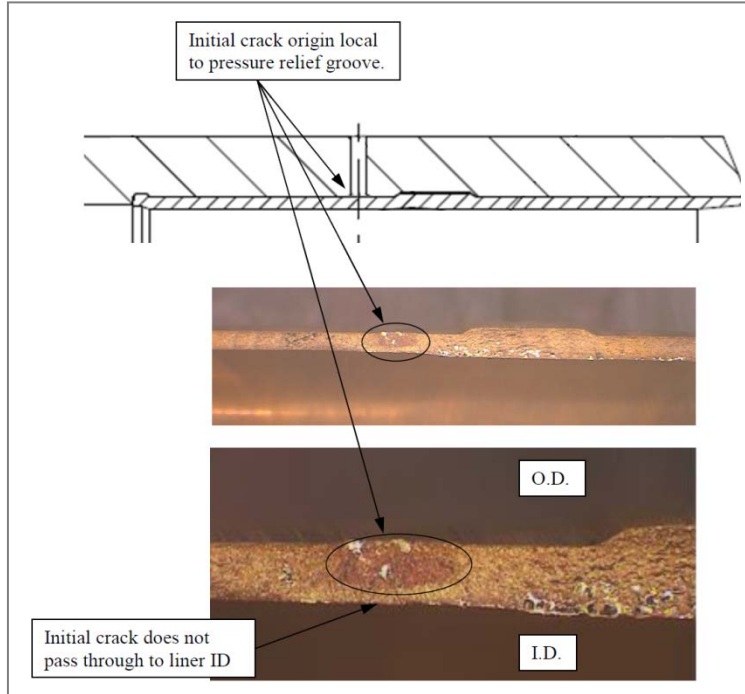
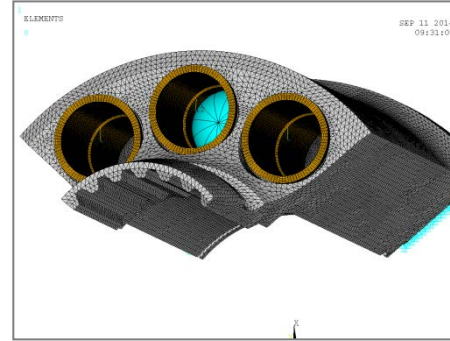
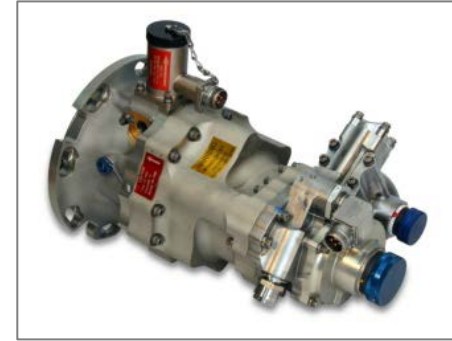
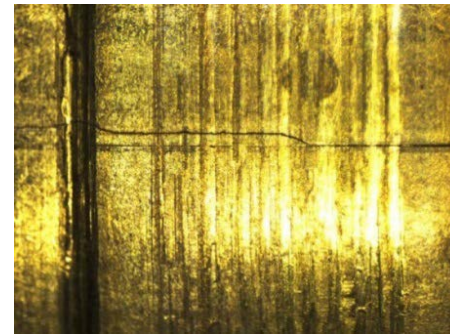
# A380 EDP Cylinder Block Sleeve Displacement – FEA

- Due to manufacturing process change to a CNC horizontal swaging operation
- The horizontal swaging method does not permit self centering of the swaging tool causing side loading
- Sleeves not always correctly aligned, scratching the outer sleeve, raising a burr and this can create stress raisers
- FEA computations confirm significant stresses are large enough to rupture material when stress raisers are present combined with tool offset

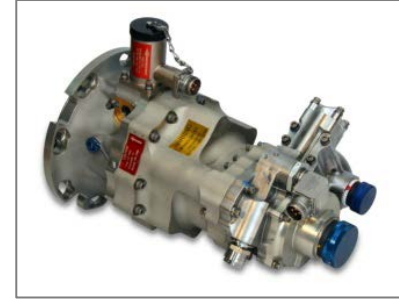
# A380 EDP Cylinder Block Sleeve Displacement – Conclusions

Root cause has been established.

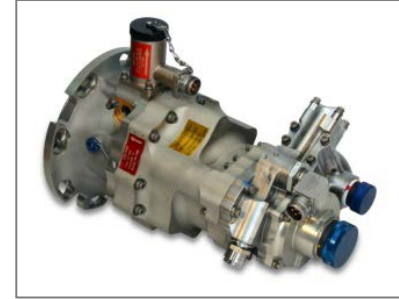
# A380 EDP Piston Shoe Delamination

- A manufacturing piston shoe plating process issue has been identified affecting a specific batch of piston and shoe subassemblies
- The problem was revealed following a test failure in Eaton's Jackson facility where a portion of piston shoe bronze had separated from 1 piston & shoe subassembly
- Additional metallurgical tests of the suspect population revealed an issue with piston shoe adhesion, the non conforming product failed to meet the minimal requirement for shoe bronze adhesion
- The affected material was used to produce 3 piston & shoe subassembly P/Ns for different pump applications. For the A380 EDP piston & shoe subassembly P/N 3031310-001 a total of 41 EDPs were shipped with material from the affected batch
- Due to slow return rate 6 retrofits completed to date.

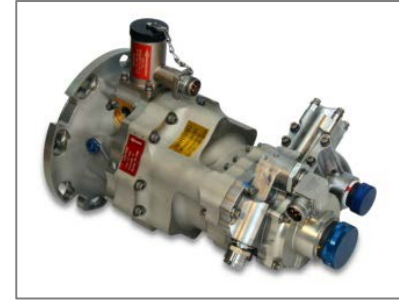
# A380 EDP Piston Shoe Delamination

- Root cause investigation determined excessive amperage was applied during the plating operation at sub-contractor
- All affected units have been identified
- All affected material has been scrapped
- Corrective actions have been put in place:
  - New work instructions
  - Additional training
  - More material sampling
  - Process control review
- All 41 affected units to be retrofitted – SIL 3032793-002-29-02 applies, retrofitted EDPs identified by S/N Suffix B.
