CFM56-7 main engine fuel pump shaft seal leakage

Product Sales Manager
FMC - Euclid

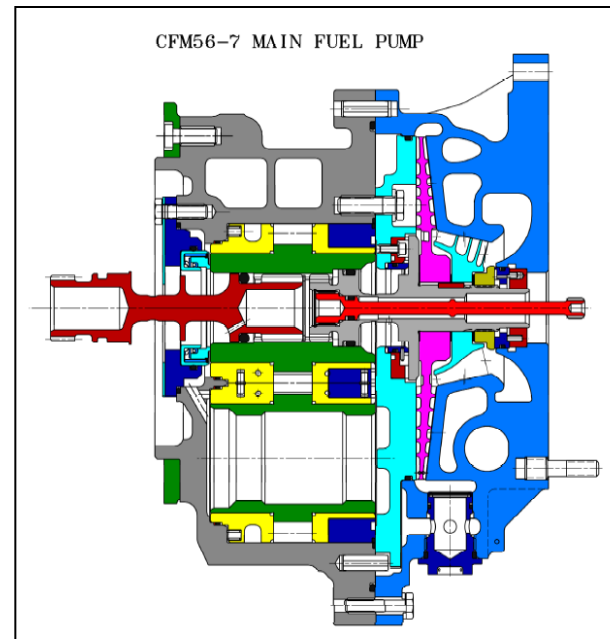
Issue/application

- Leakage from overboard drain mast
- CFM56-7 / 737 NG Main Engine Fuel Pump
 - Pump model 828300
- Lightly loaded seal provides long life
 - Early Tec-ring configured shaft seals in 828300-3/4/5 pumps prone to weeping
 - Later O-ring configured shaft seals in 828300-5/8 pumps exhibit occasional heavy leakage at engine start

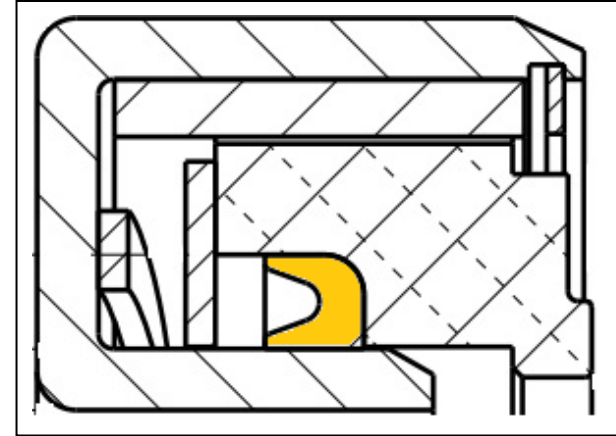
Tec-ring configured shaft seal

- OEM shaft seal 1994 through 2008
- Occasional leaks overnight or during inactive periods
- Typically low rate leakage – < 0.1 cc/min and often considerably less
- Leakage stops during 5-minute ground engine run (trouble-shooting per AMM)
- Leakage reoccurs frequently

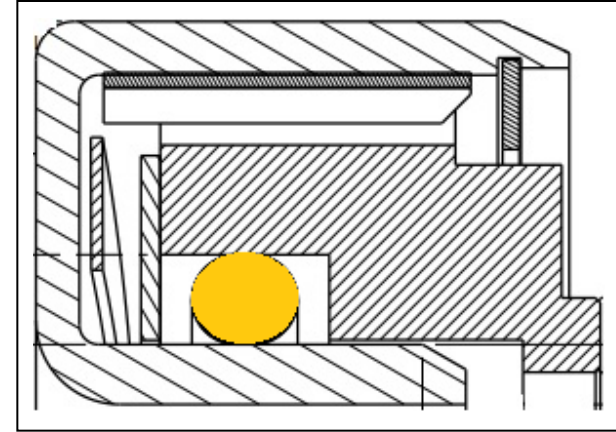
O-ring configured shaft seal

- Pump leaks at first start of the day
- Leakage is heavy stream
- Leakage stops during 5-minute ground engine run (trouble-shooting per AMM)
 - Zero leakage measured in 5 minutes
- Leakage events recur intermittently
 - 1 day to 4 months between leakage events
 - Pump removed when leakage exceeds AMM limit, pilot request or after repeated leaks

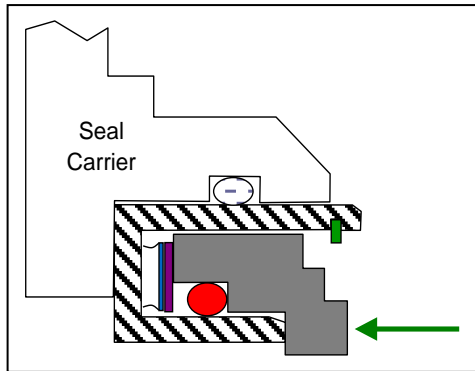
- Leak caused by separation between carbon nose and seal runner (seal-liftoff) at engine start condition
 - Requires axial movement of seal during prior engine shutdown/cooldown

Seal compressed – O-ring slides on cup neck

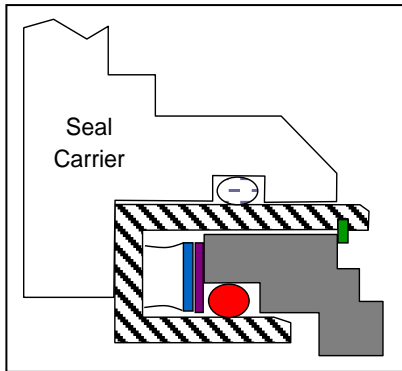
Seal extends – O-ring *rolls* away from carbon nose piece leaving gap between O-ring and carbon piece gland wall

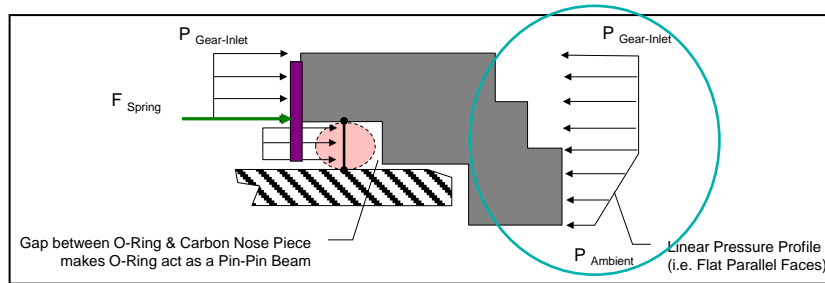
- Leak caused by separation between carbon nose and seal runner (seal-liftoff) at engine start condition
 - Requires atypical pressure distribution across carbon

Seal compressed – O-ring slides on cup neck

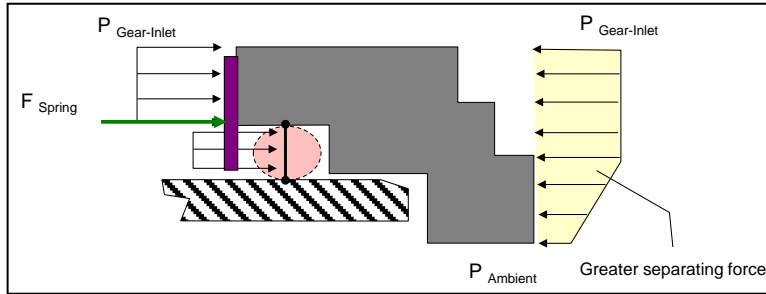
Current design

Lift-off likely due to low pressure balance ratio

Low pressure balance ration

- Higher separating force
- More susceptible to process variation
- Lower face pressure (less wear)

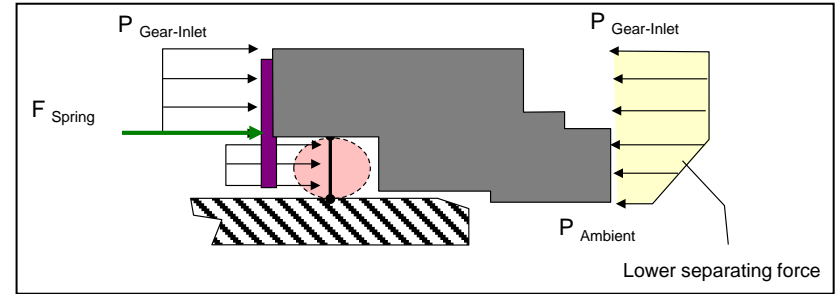
High pressure balance ration

- Lower separating force
- Less susceptible to process variation
- Greater face pressure (more wear)

- Shaft seal redesign agreed between Eaton and Snecma
 - Redesign eliminates the shaft seal lift-off by addressing 2 of the 3 contributing factors (Increased pressure balance and elimination of cup axial movement during transients)
 - Significantly reduces risk of “lift off” due to process variation
 - Anticipated availability is Q2 2017

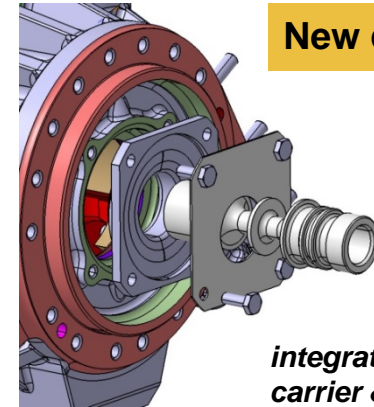
New config.

integrates current seal carrier & seal

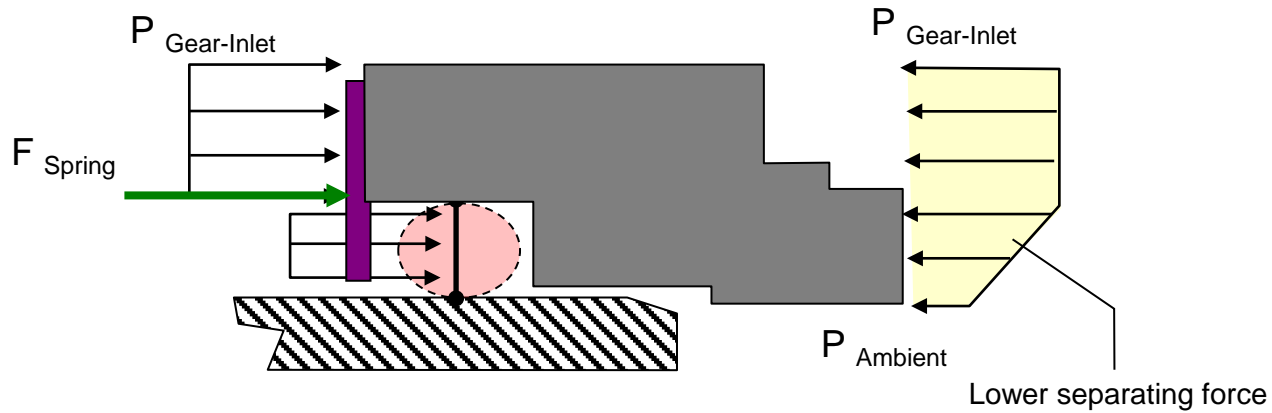
High pressure balance ration

- Lower separating force
- Less susceptible to process variation
- Greater face pressure (more wear)
