CFM56-7B S/B 80-0016 – Introduction of New V-Band Clamp VIN 31428-6600 (P/N 2635M04P01)

CFM56-7B S/B 80-0016: Introduction of New V-Band Clamp VIN 31428-6600 (P/N 2635M04P01)

7B_80-0016R0 Coupling retrofit Eaton p/n 31428-6600

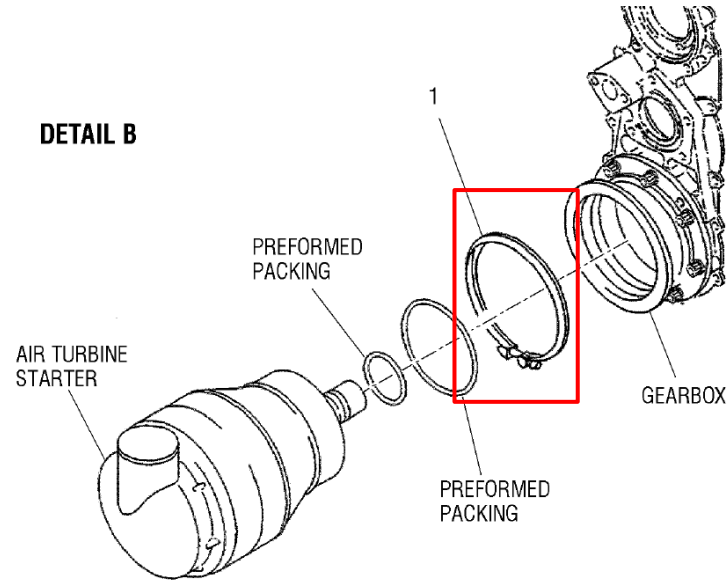
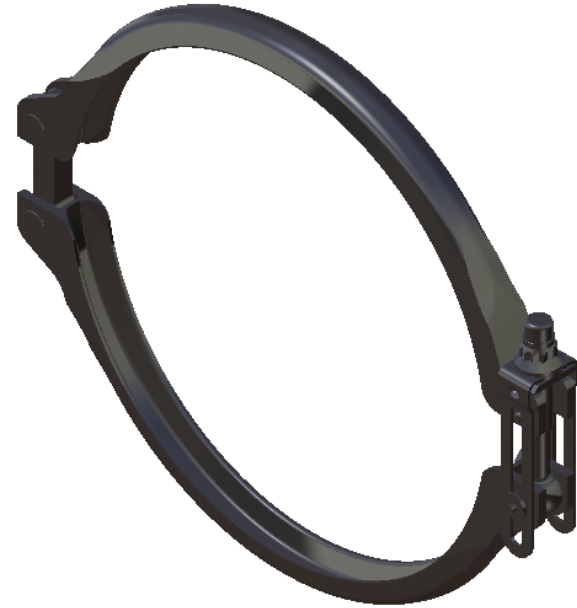
Eaton P/N 31428-6600

- Introduce new part with improved reliability & maintainability.
- Replace cracked Sheet metal V-band clamps that have failed and caused oil loss at the gear box interface in the field resulting in In-Flight Shut Downs (IFSDs)

- The welded sheet metal clamp is known to crack in the weld and fails in High Cycle Fatigue (HCF). Overtorque during installation of the Sheet metal clamp is known to increase the likelihood of cracking

- New design is a Machined Clamp (No Welds)
 - The new part is constructed with fully machined components and this designs out the weld thus eliminating the failure mode
- Improved margin to installation over torque
 - New Machined clamp is torqued to a higher torque range, 115-125 lb-in, which is aligned to common pneumatic system couplings on the engine

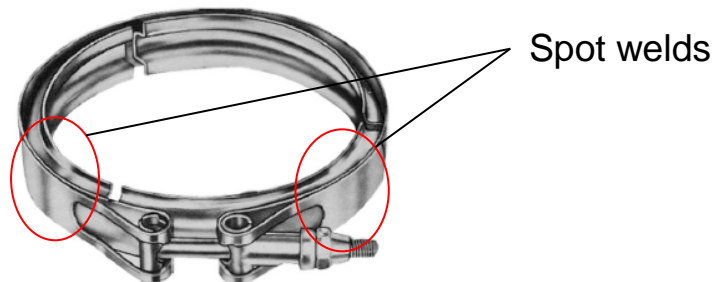
Sheetmetal coupling

- Contains welds
- Manufactured from stainless steel sheet
- Installation torque = 49-55 lb-in
 - Highly sensitive to overtorque

Machined coupling

- No welds - fully machined
- Manufactured from heat resistant alloys
 - A-286 retainers
 - Inconel 718 & A-286 hardware
- Increased margin compared to sheetmetal coupling
- Installation torque = 115-125 in-lb
 - Torque marked on part
 - Torque common to similar machined couplings on the engine

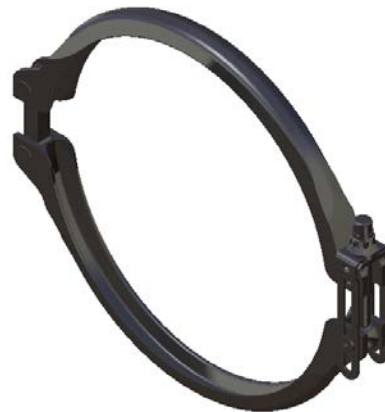
No spot welds
