# CFM56 VBV gear motor improvement status

**Kurt Kachler**

Product Sales Manager  
FMC – Euclid (Engine Fuel)

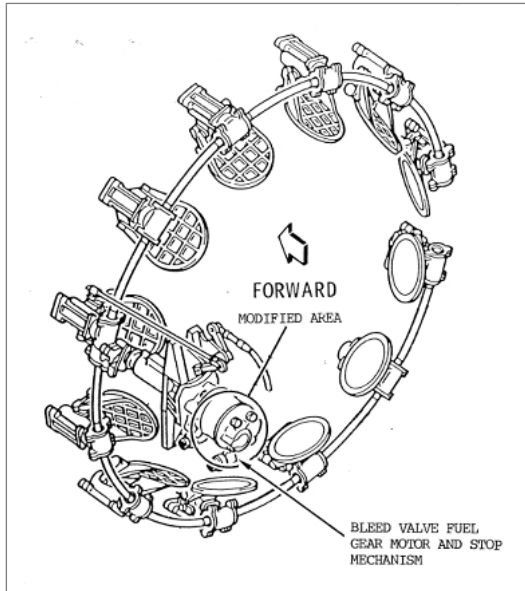
## Increased torque requirements of CFM56-5B VBV system drives maintenance

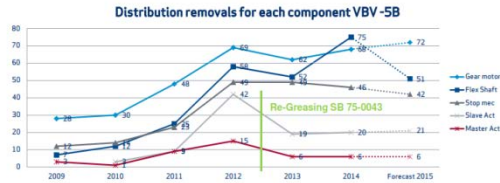
### -5B Evolution of removed components

- Component removals based on data supplied to CFM – since 2009
- Gear Motor, Stop Mechanism & Flexshafts are the most removed VBV components (~75% of total removals)

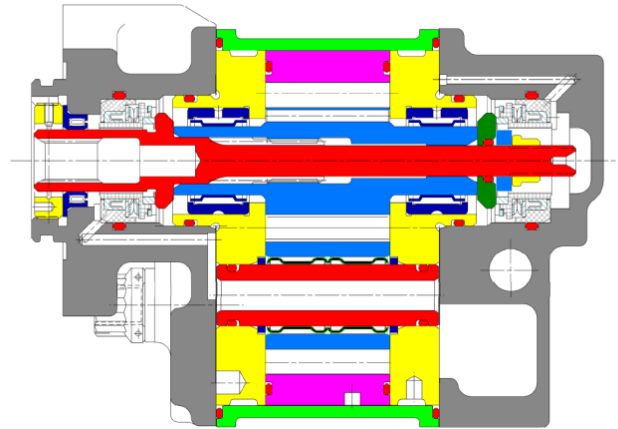
Heavy wear of bearing races leads to contact between the gear tips and gear housing.

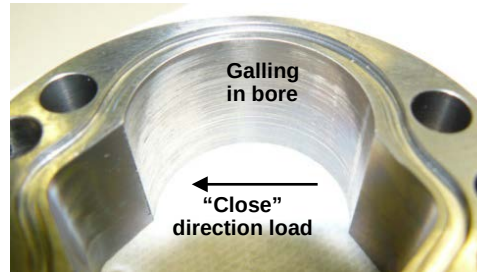
Housing scoring that leads to seizure due to journal and shaft wear

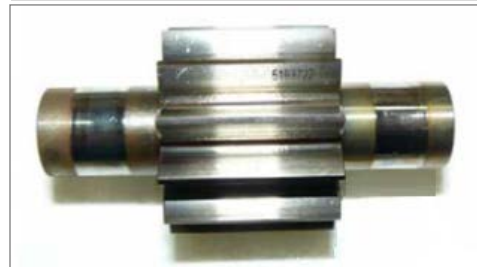
Typical drive gear journal wear

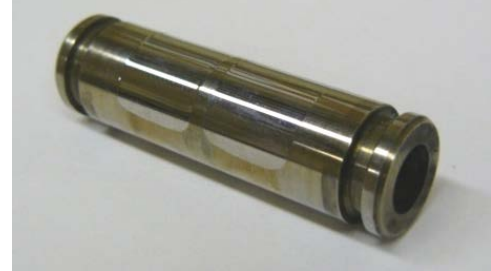
Idler shaft wear (One heavily loaded quadrant)

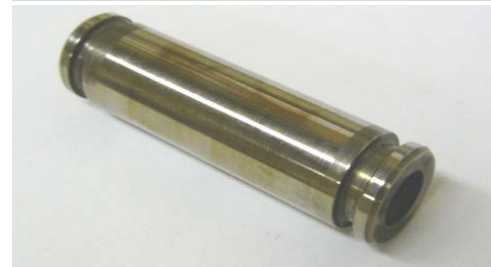
Idler shaft (Opposite side not worn)

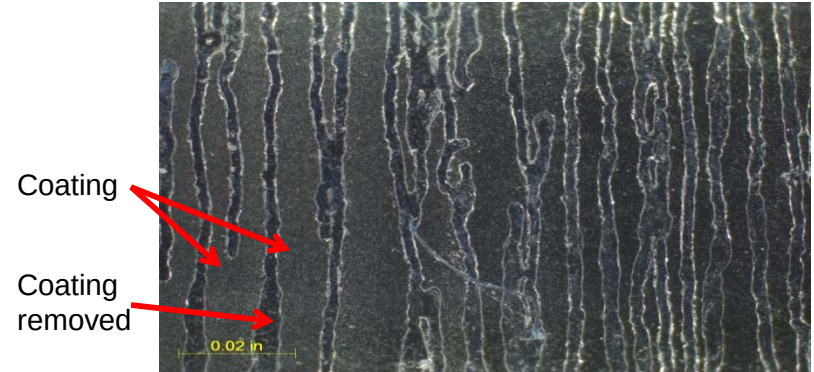
- Initial development testing of Titanium Zirconium Di-Boride (TZB) coating looked very promising
- Inconsistent coating adhesion was experienced
- Process to eliminate the base metal re-crystallized layer from super finish to improve TZB adhesion
- Continuing adhesion issue drove evaluation of alternative coatings

### PVD coating missing following production acceptance test
