CRJ-200 Flap actuator tungsten carbide upgrade

Tyler Curtis

Mechanical & Sustaining Engineering Manager
FMC Grand Rapids, MI

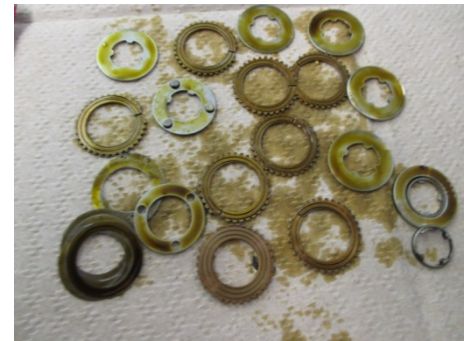
Historically, two of the largest problem areas for the CRJ200 flap actuators are pinion grooving and insufficient sealing capability

Inner and outer pinion journals require a harder coating to avoid wear during use, which results in early replacement of an expensive part

The associated failure mode is leakage through the inner or outer seals. If these seals leak, oil from the gearbox or grease from the flex shaft contaminates the spring pack or brake plates. At low temperatures, the contamination thickens and results in “soft jams”

Grooving is believed to accelerate the leakage failure mode by providing a leakage path through the seals

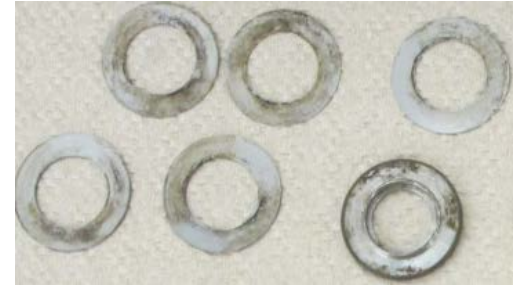
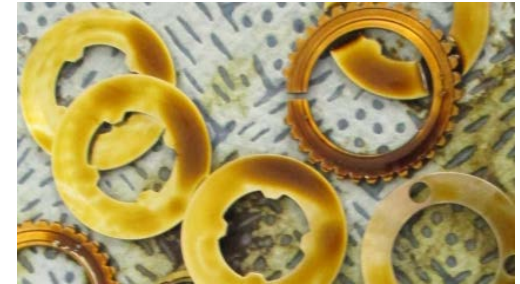
In Q4 of 2014, Eaton conducted a screening procedure on (45) returned flap actuators.

Results indicate no connection between grooving and small leaks, but a strong tie between grooving and large leaks.

- Small leaks had a groove on the corresponding seal journal only 16% of the time. (25 units, Left)
- For large leaks, this number jumped to 72%. (11 units, Right)

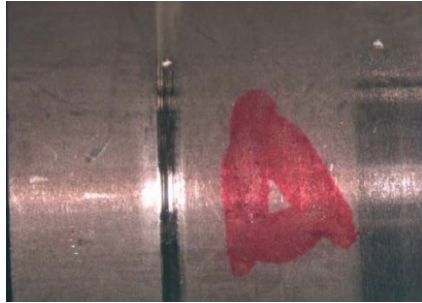
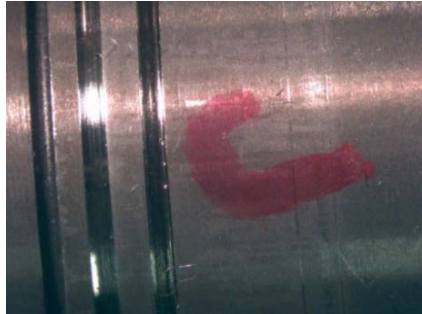
Chrome – 21,000 cycles

- Actuator Failure: 21,000 Cycles
- Grooving: Several – Depths between 0.0005 and 0.0025". Found on inner seal journals
- ATP Failed: Low Temperature Input Torque (-40 C, Breakaway)
- Root Cause: Leakage through the inner seals

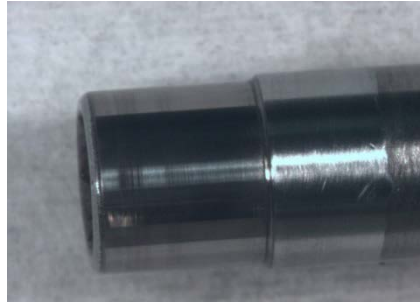
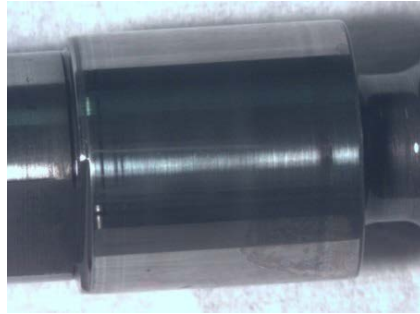
Tungsten – 39,134 cycles

- Actuator Failure: 39,134 Cycles
- Grooving: None
- ATP Failed: Rated Torque, Torque Absorber Not Activated
- Root Cause: Spalling found on high side of pinion gear teeth. Failure is unrelated to tungsten-coated surfaces
