A380 Electric Motor Pump status update

Product Support Manager Bedhampton FMC Hydraulics

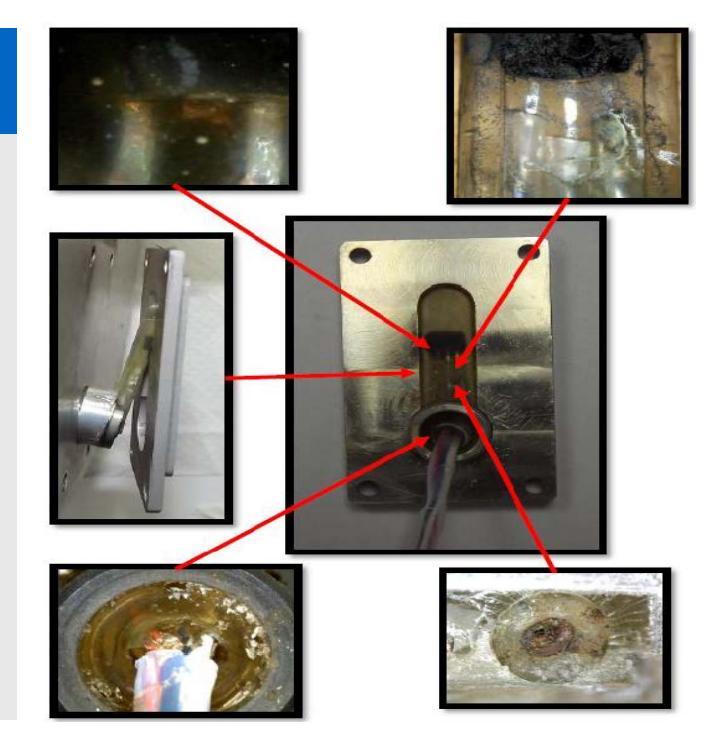
Electric Motor Pump Speed Sensor Technical Issues

The speed sensor has experienced the following technical issues

- Potting compound ejecting from housing, exposing vulnerable areas of the sensor and its leads to ingress of moisture and contaminants
- Potting compound degradation exposing the speed sensor leads to moisture and contaminants
- Poor potting compound adhesion to PTFE wires, creating potential ingress path for moisture and contaminants
- When the issues are combined with the constant +15Vdc bias applied to the sensor, the following effects have been seen:
 - Dendritic growth between +15V and GND speed sensor leads
 - Dendritic growth between Signal and GND speed sensor leads causing short circuit conditions and intermittent faults
 - · Corroded sensors causing open circuit conditions

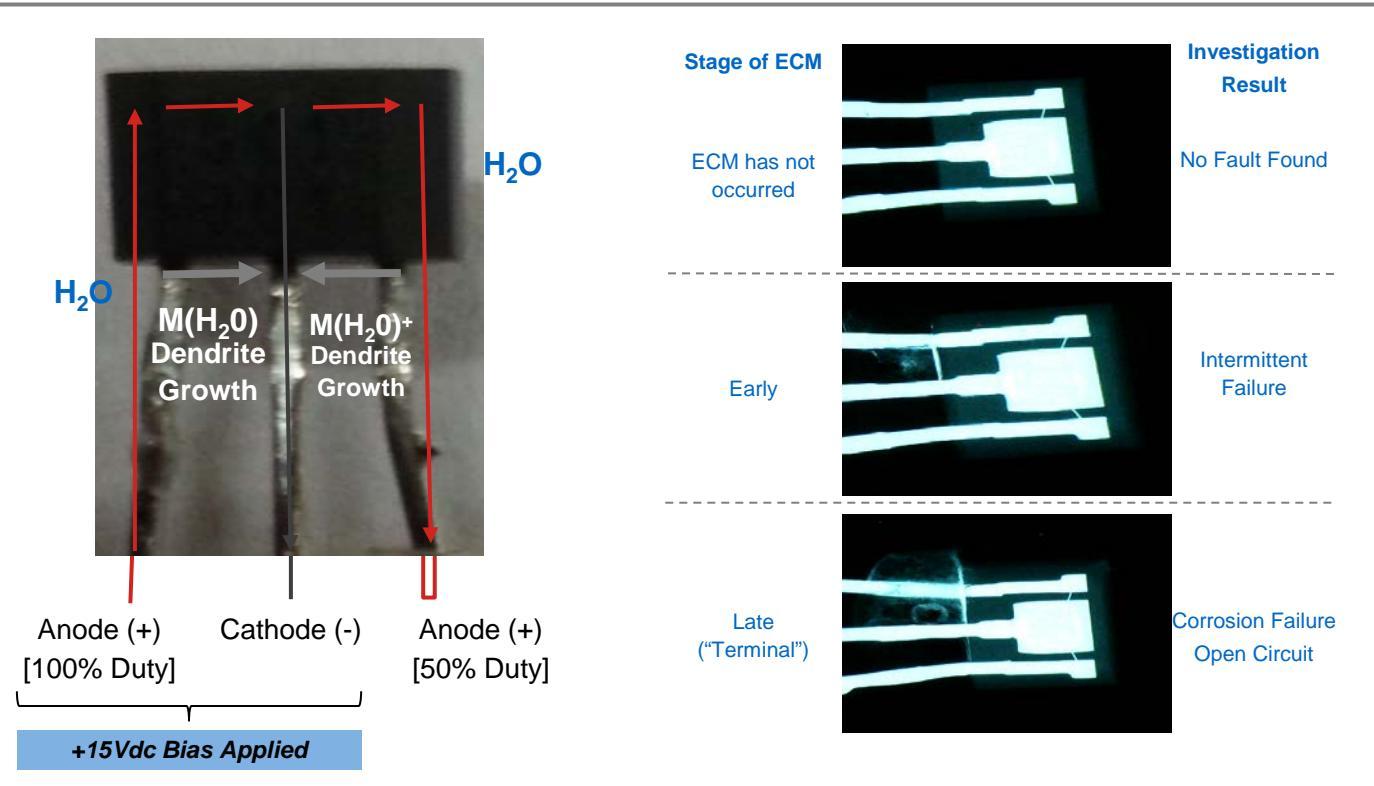
Electric Motor Pump Root Cause - Electrochemical Migration

- Moisture and contaminants can be present in the immediate vicinity of the hall effect sensor leads due to failure of the potting compound
- A potential gradient of 4.54V/mm is constantly present on the power supply lead, and half the time on the signal lead
- The hall effect sensor leads suffer an electrolytic effect which produces mobile metal ions, the material which forms dendrites
