# B787 Fuel Pump Technical Update - F202

**Stuart Tucker** Product Support & Technical Services Manager  
**Billy Walker** Technical Support Team Leader  
Aftermarket FMC

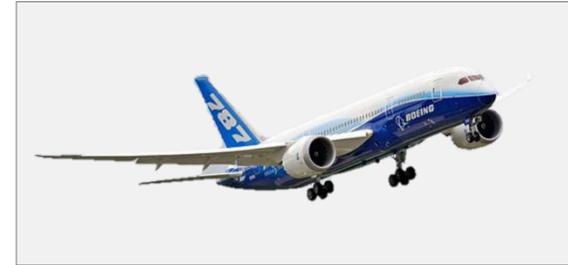
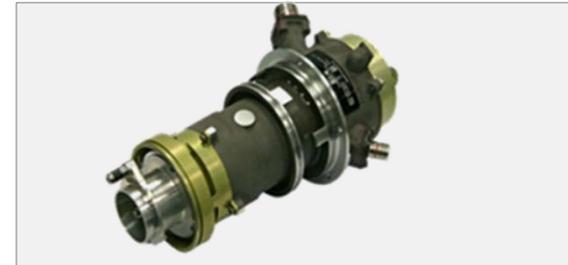
# 787 In-service issues – boost pump

### Failure of Stator Windings on in-service aircraft

- Initial determination – damage to Stator Winding insulation during assembly resulting in weakened electrical resistance causing electrical short circuit
- Manufacturing process change implemented to address possible insulation damage during assembly
- Part number roll from -1300 to -1400 identifying process change
- Fleet retrofit of all 1300 pumps – Complete

**Issue diminished but was not resolved**
