B787 Program update - F205

Stuart Tucker Product Support & Technical Services Manager
Billy Walker Technical Support Team Leader
Aftermarket FMC

Boeing 787 Fuel system background

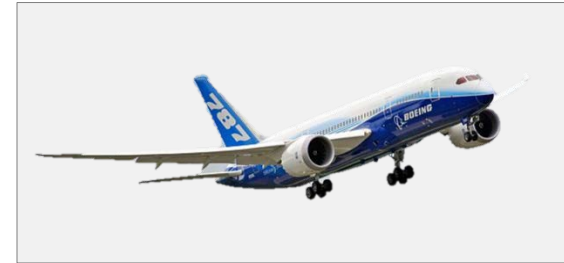
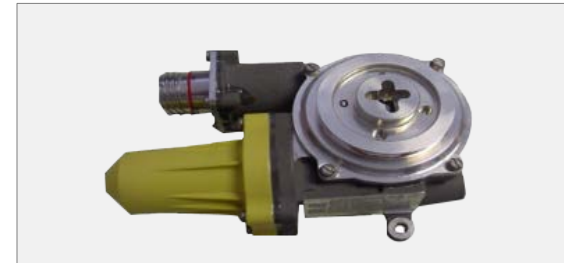
- **Platform:**
 - Boeing 787-8
- **Aircraft problem/impact:**
 - To meet compliance with 25.901(c)
- **Description of problem**
 - Original design, without diodes, only the destination position is signalled and to address in-service failures
- **Identify assembly/part number:**
 - Fuel Valve Actuator PN 53-0037 to -0049
- **Consequence(s)**
 - Modification of 6 locations on Aircraft

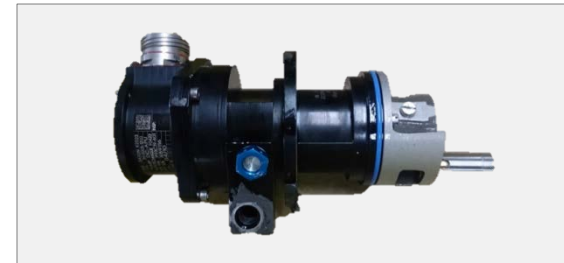
- **Platform:**
 - Boeing 787-8
- **Aircraft problem/impact:**
 - Failure of APU pump
- **Description of problem**
 - CE2825801 APU DC Pump circuit breaker was found tripped and the pump was placed inoperative. Pump end cap detached.
- **Identify assembly/part number:**
 - APU P/N 39-0005-1200
- **Consequence(s)**
 - Potential modification to overcome issue

Some operators advised issues relating to the CE2825801 APU DC Pump circuit breaker tripping and the APU pump being inoperative

Pump end cap was also found detached

Investigations revealed damage to the MOV (Metal Oxide Varistor), and in some cases damaged capacitors
