# A380 Engine Driven Pump Status Update

# Historical Background

# A380 EDP Manufacturing Issues / Retrofits

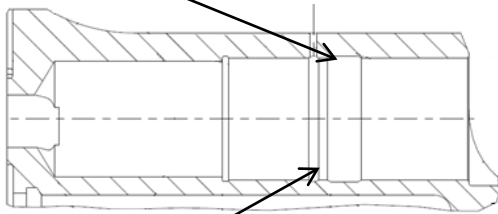
## Cylinder block bore

Swage retention groove

Swage relief groove and hole

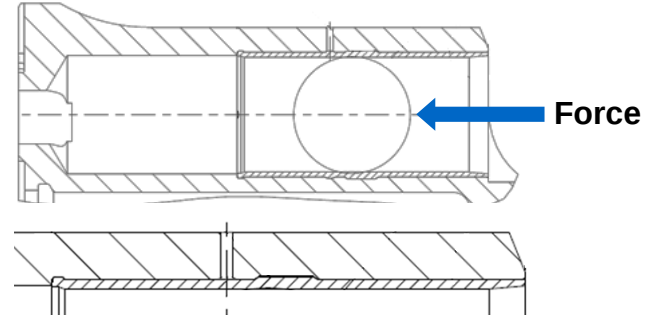
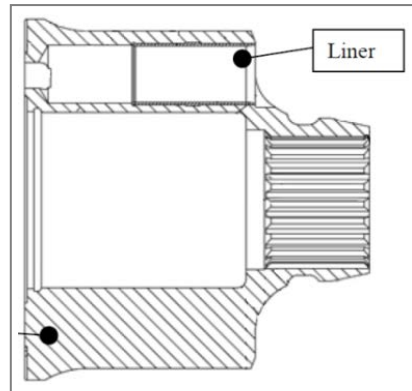
## Bore and sleeve swaging

Investigation confirmed a new failure mode. The failure mechanism was not the same as previous sleeve displacement incidents.

Cracks were found on outer sleeve diameter and undetectable by NDT post swaging.

Root cause was linked to a swaging process change where the swaging operation method was changed from a vertical to horizontal method.

Horizontal swaging resulted in side loading the sleeve due to tool wear.

Side loading can cause the outer sleeve to fracture due to poor alignment.

- The key contributor is directly related to using the horizontal CNC milling machine to swage the sleeves causing mis-alignment
- This is eliminated by returning the swaging operation to a vertical press.
- Vertical swaging self aligns naturally to each bore and there is no opportunity for side loading to occur
- Worth mentioning is the fact that the vertical swaging operation used to retrofit the global fleet to the PV3-300-31N standard is a well proven and robust manufacturing process. There are no recorded incidents of sleeve displacements with 1000+ PV3-300-31N EDPs produced.
- All 203 affected units will be retrofitted with a new cylinder block– SIL 3032793-002-29-01 applies, retrofitted EDPs identified by S/N Suffix A. A total of 154 retrofits completed to date.

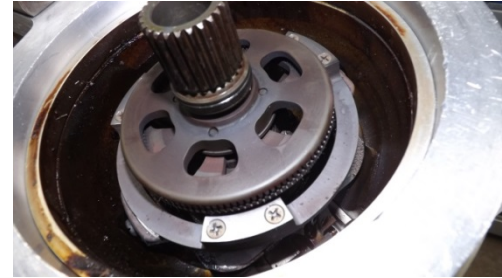
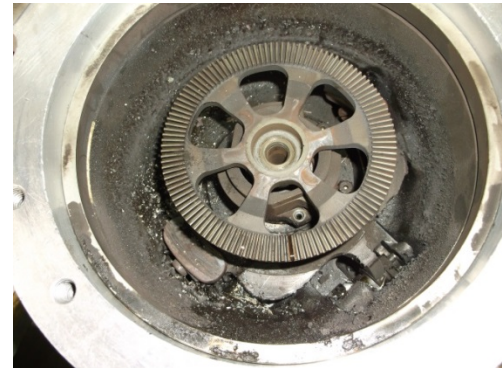
Incorporates new thermal barrier

Reduce heat transfer to the EDP clutch cavity from the Accessory Gear Box (AGB)

The thermal barrier is intended to resist high temperature blown air from the AGB

Combat the formation of thermally stressed fluid inside the mounting flange cavity
