# CFM56 VBV gear motor improvement status

**Kurt Kachler**

Product Sales Manager  
FMC – Euclid (Engine Fuel)

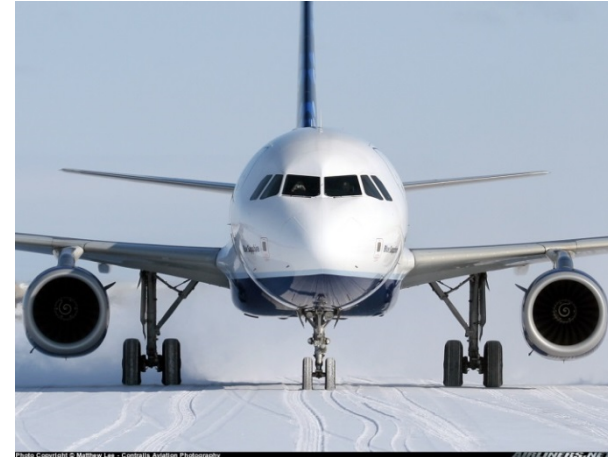
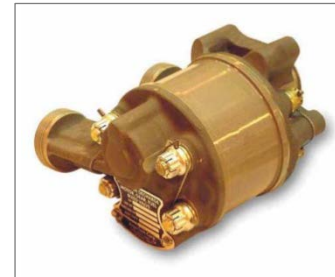
- Platform: CFM56-5B engines (A320 family)
- Aircraft problem/impact
  - Aborted Take-Offs (ATOs), Air Turn-Backs (ATBs), Delays and Cancellations
- Description of problem
  - Inability to control air into the engine core compressor due to heavy wear of the entire CFM56-5B Variable Bleed Valve (VBV) system driven by Eaton's VBV gear motor
- Assembly/part number
  - 396800-12 VBV Gear Motor (CFM 301-774-709-0)
- Additional maintenance is required to insure reliable operation
