CRJ-200 Flap actuator tungsten carbide upgrade

Tyler Curtis

Mechanical & Sustaining Engineering Manager
FMC Grand Rapids, MI

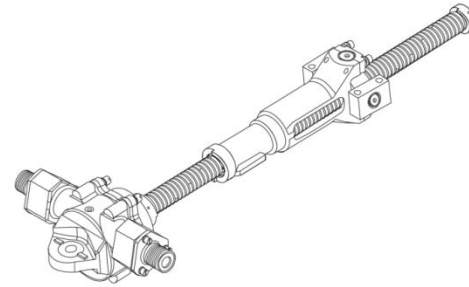
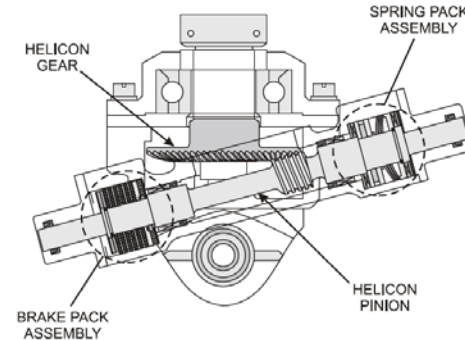
- A helicon pinion receives torque from the PDU by way of a flex shaft
- The pinion drives a helicon gear, transferring rotary motion of the pinion into linear motion of the ballscrew
- A set of belleville springs and brake plates limits the output force of each actuator

Historically, two of the largest problem areas for the CRJ200 flap actuators are pinion grooving and insufficient sealing capability

Inner and outer pinion journals require a harder coating to avoid wear during use, which results in early replacement of an expensive part

The associated failure mode is leakage through the inner or outer seals. If these seals leak, oil from the gearbox or grease from the flex shaft contaminates the spring pack or brake plates. At low temperatures, the contamination thickens and results in “soft jams”

Grooving is believed to accelerate the leakage failure mode by providing a leakage path through the seals

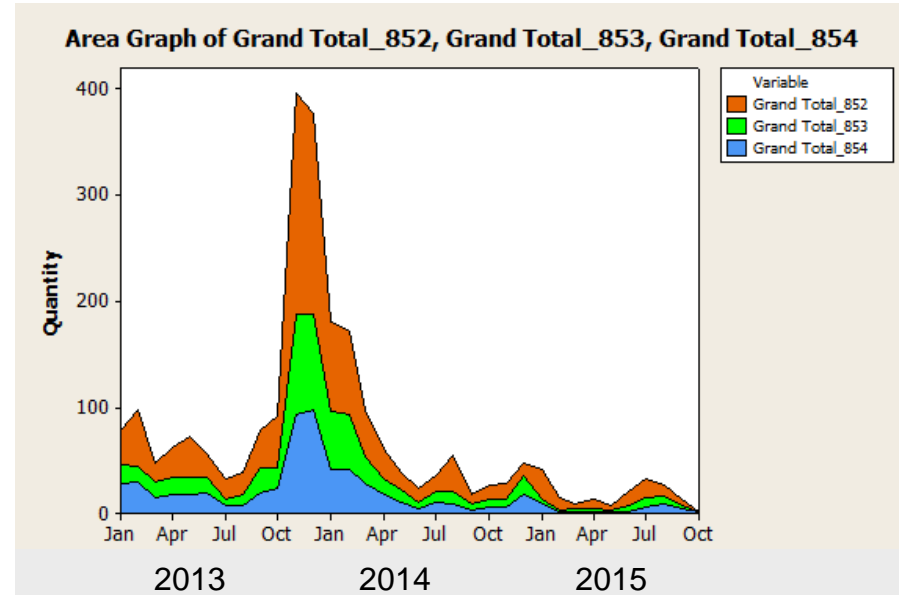
- Seal restoration program accomplished Oct-Apr of 2014
- Since seal restoration there has been a reduction in the rate of returns to Eaton's repair station
